MEMORANDUM

DATE November 1, 2012
TO MassDOT Highway Division District 4
Town of Danvers
FROM Chen-Yuan Wang, Mark Abbott, Steven Andrews, and Christine Bettin
MPO Staff
RE Route 114 in Danvers, Interstate 95 to the Peabody City Line:
Safety, Operations, and Access Management Study

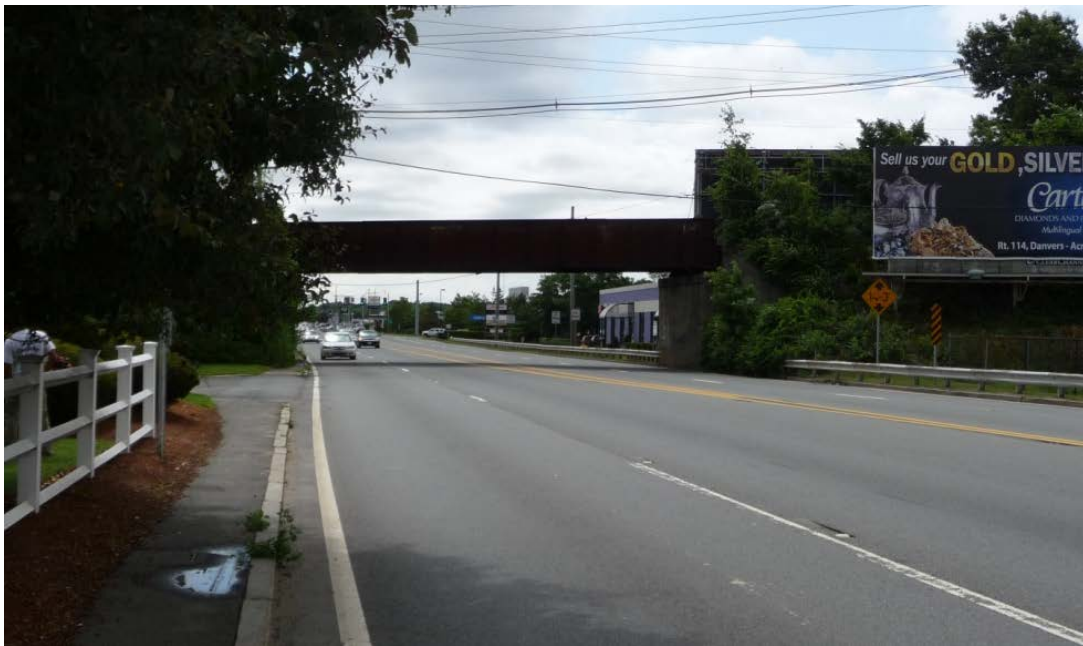
In this corridor, a bridge that used to carry trains and now is a section of the Danvers Rail Trail spans Route 114 located about 300 feet east of Garden Street. The area under the bridge is the narrowest section of the corridor, which has a lateral clearance of about 60 feet or less (see the picture below).

Roadway conditions near the Danvers Rail Trail bridge

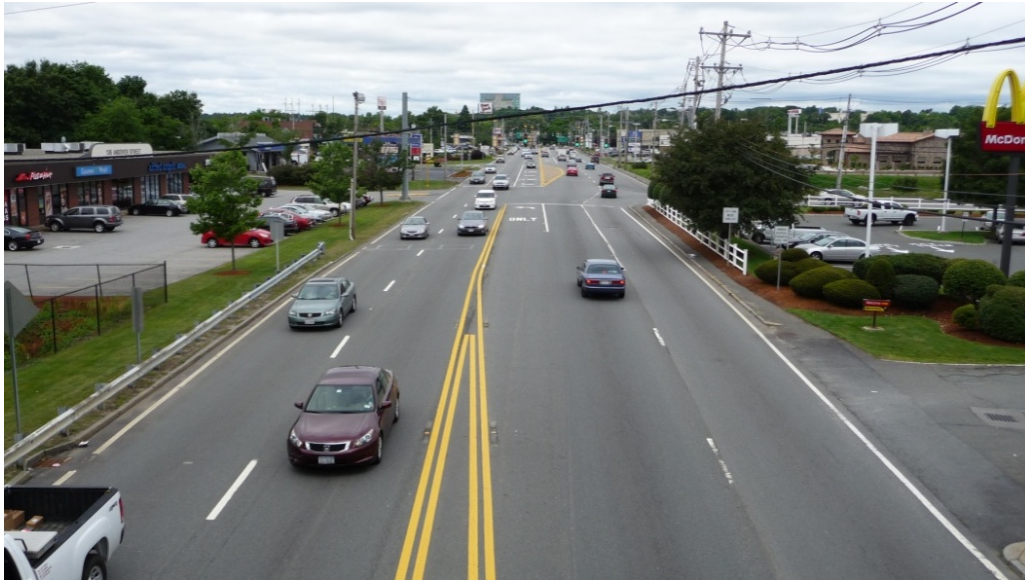
Most sections in the corridor contain five travel lanes, two in each direction for through and right-turning traffic and a middle lane for left-turning traffic. The middle lane is configured either as an exclusive left-turn lane or as a two-way left-turn lane (TWLTL). The following two pictures show the existing roadway conditions on Route 114 in the vicinity of the rail bridge.

Street view, looking west from the Danvers Rail Trail bridge

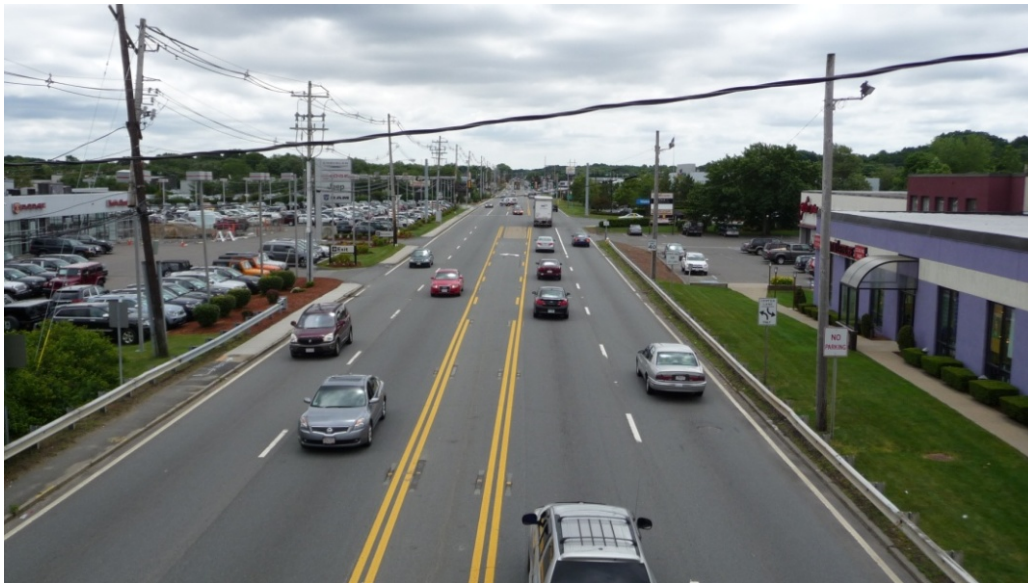
Street view, looking east from the Danvers Rail Trail bridge

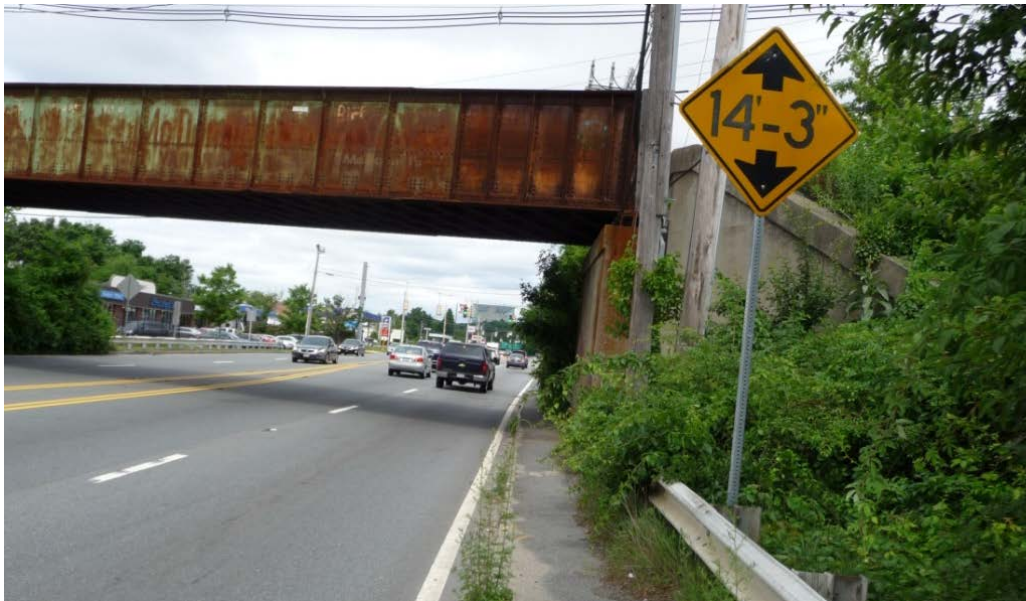
Along Route 114, there is a four-foot-wide sidewalk on the north side of Route 114 and no sidewalk on the south side. In the one-mile study section, there is only one crosswalk across Route 114, located west of Brooksby Village Drive. The pedestrian crossing distance across Route 114 varies from approximately 60 feet to 80 feet. Most sections of the sidewalk are in fair condition. The section under the Danvers Rail Trail bridge is somewhat narrower than four feet and is deteriorating. Weeds growing from the sidewalk occupy sidewalk space. It is uncomfortable and unsafe for pedestrians to walk in this section (see the picture below).

Sidewalk conditions under the Danvers Rail Trail bridge

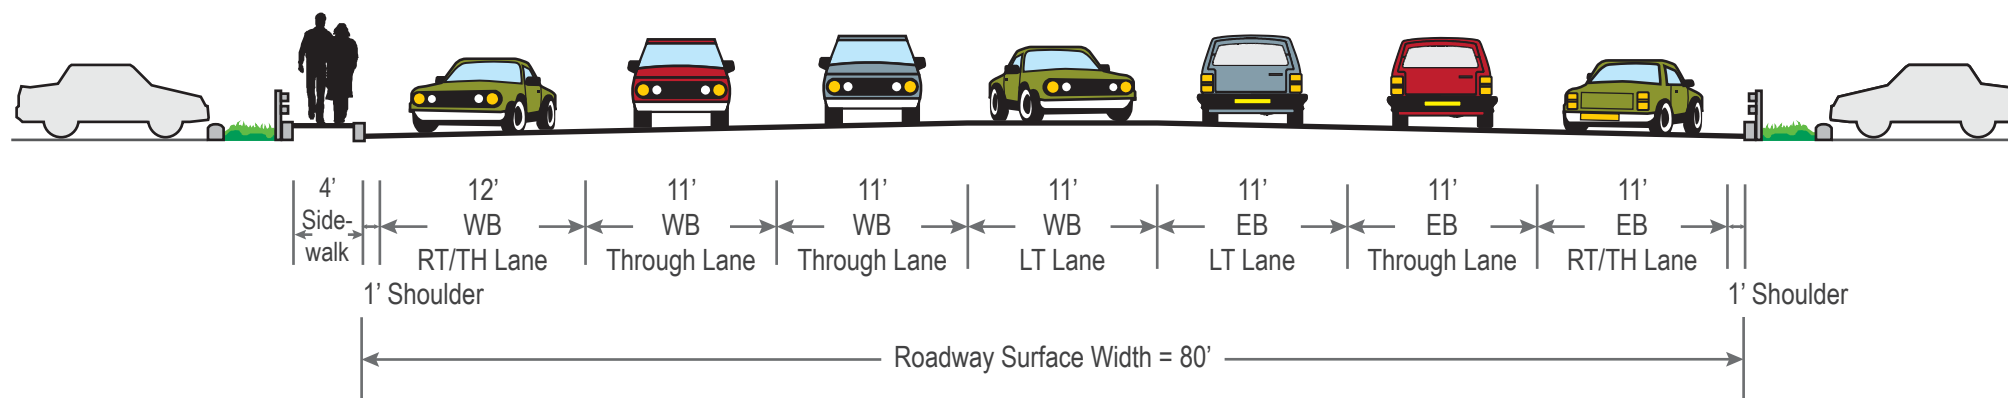
Section I: Route 114 from I-95 Interchange to Garden Street

Street cross-sections are essential for analyzing the accommodation of various travel modes in a transportation corridor. This study corridor was classified into three different cross-sections for this study. Figure 5 shows the major components in the three different sections. The cross-sections present street views looking east by an eastbound driver. The major characteristics of each of the three sections are summarized below. It should be noted that the measurement of the various roadway elements were approximated from field observations and aerial photography, not from actual field surveys.

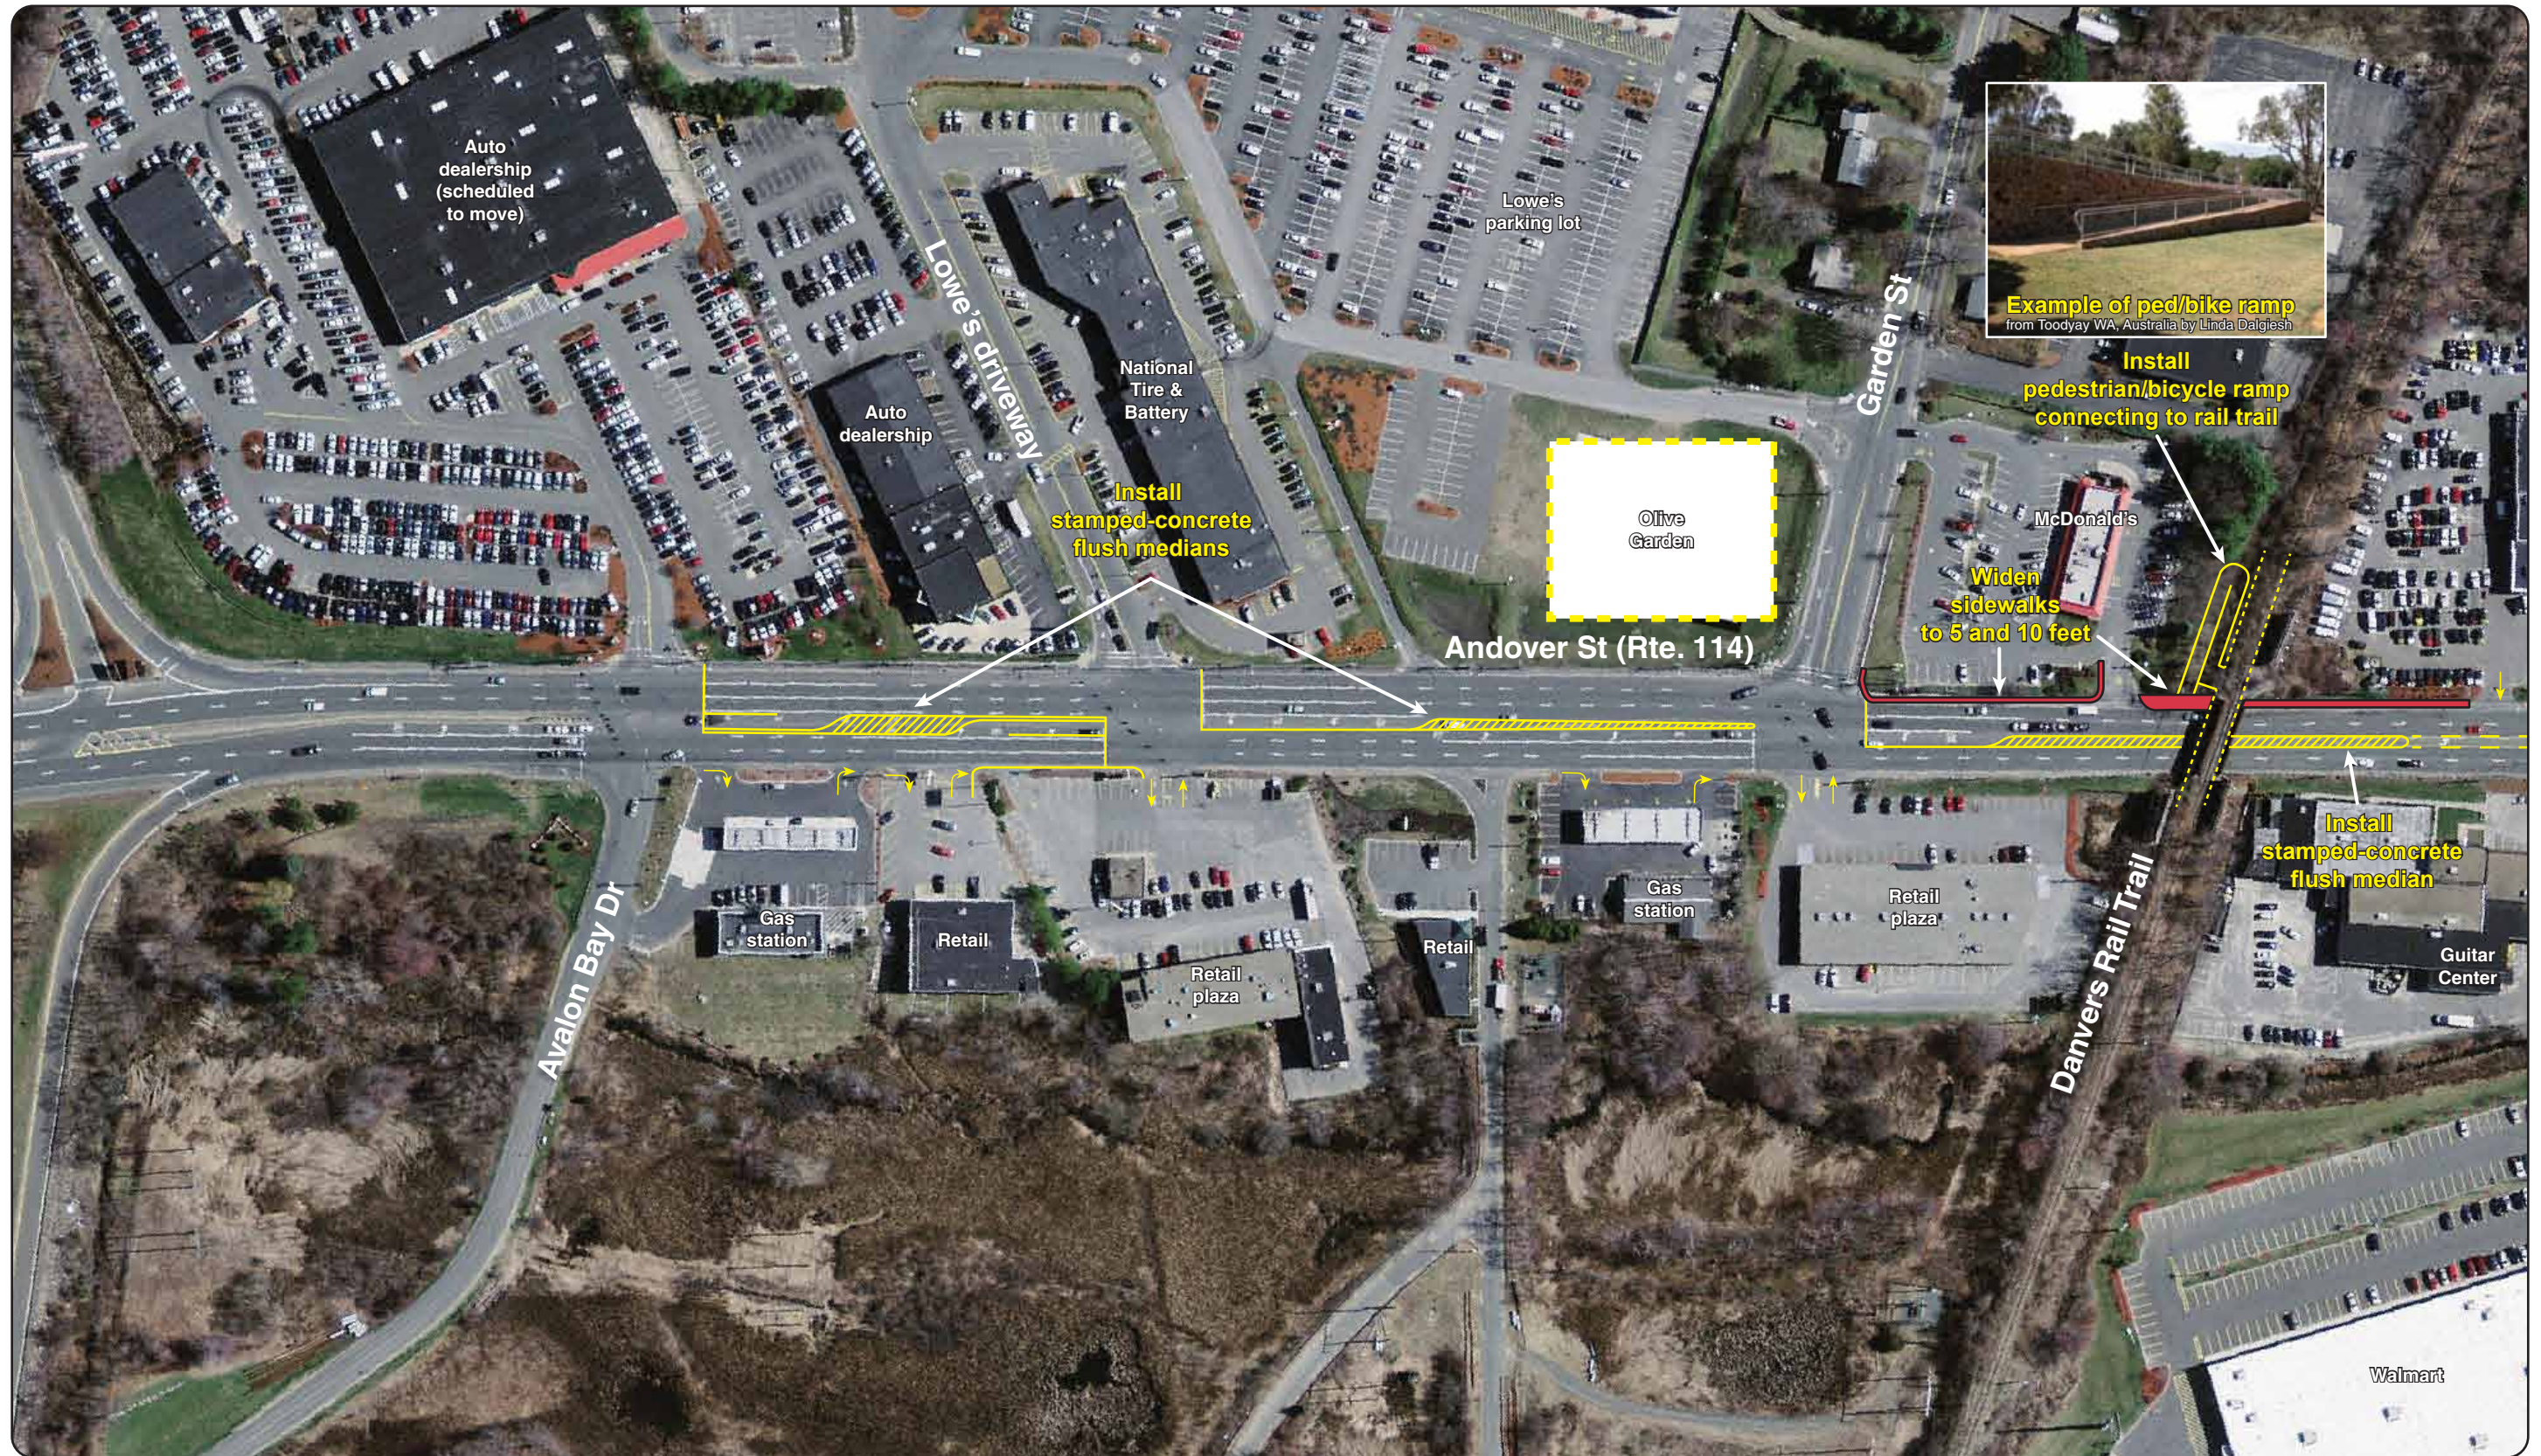
FIGURE 8
Proposed Long-Term Improvements – Alternative 1
Conceptual Plan (Western Section)

To show the locations and layouts of the proposed improvements in Alternative 1 for the entire study corridor, the conceptual plan is presented in three parts: the western section, from the I-95 Interchange to Danvers Rail Trail (see Figure 8); the middle section, from Danvers Rail Trail to the storefront retail (see Figure 9); and the eastern section, from the storefront retails to the Peabody City line (see Figure 10). The proposed improvements in Alternative 1 include the following roadway modifications and reconstruction:

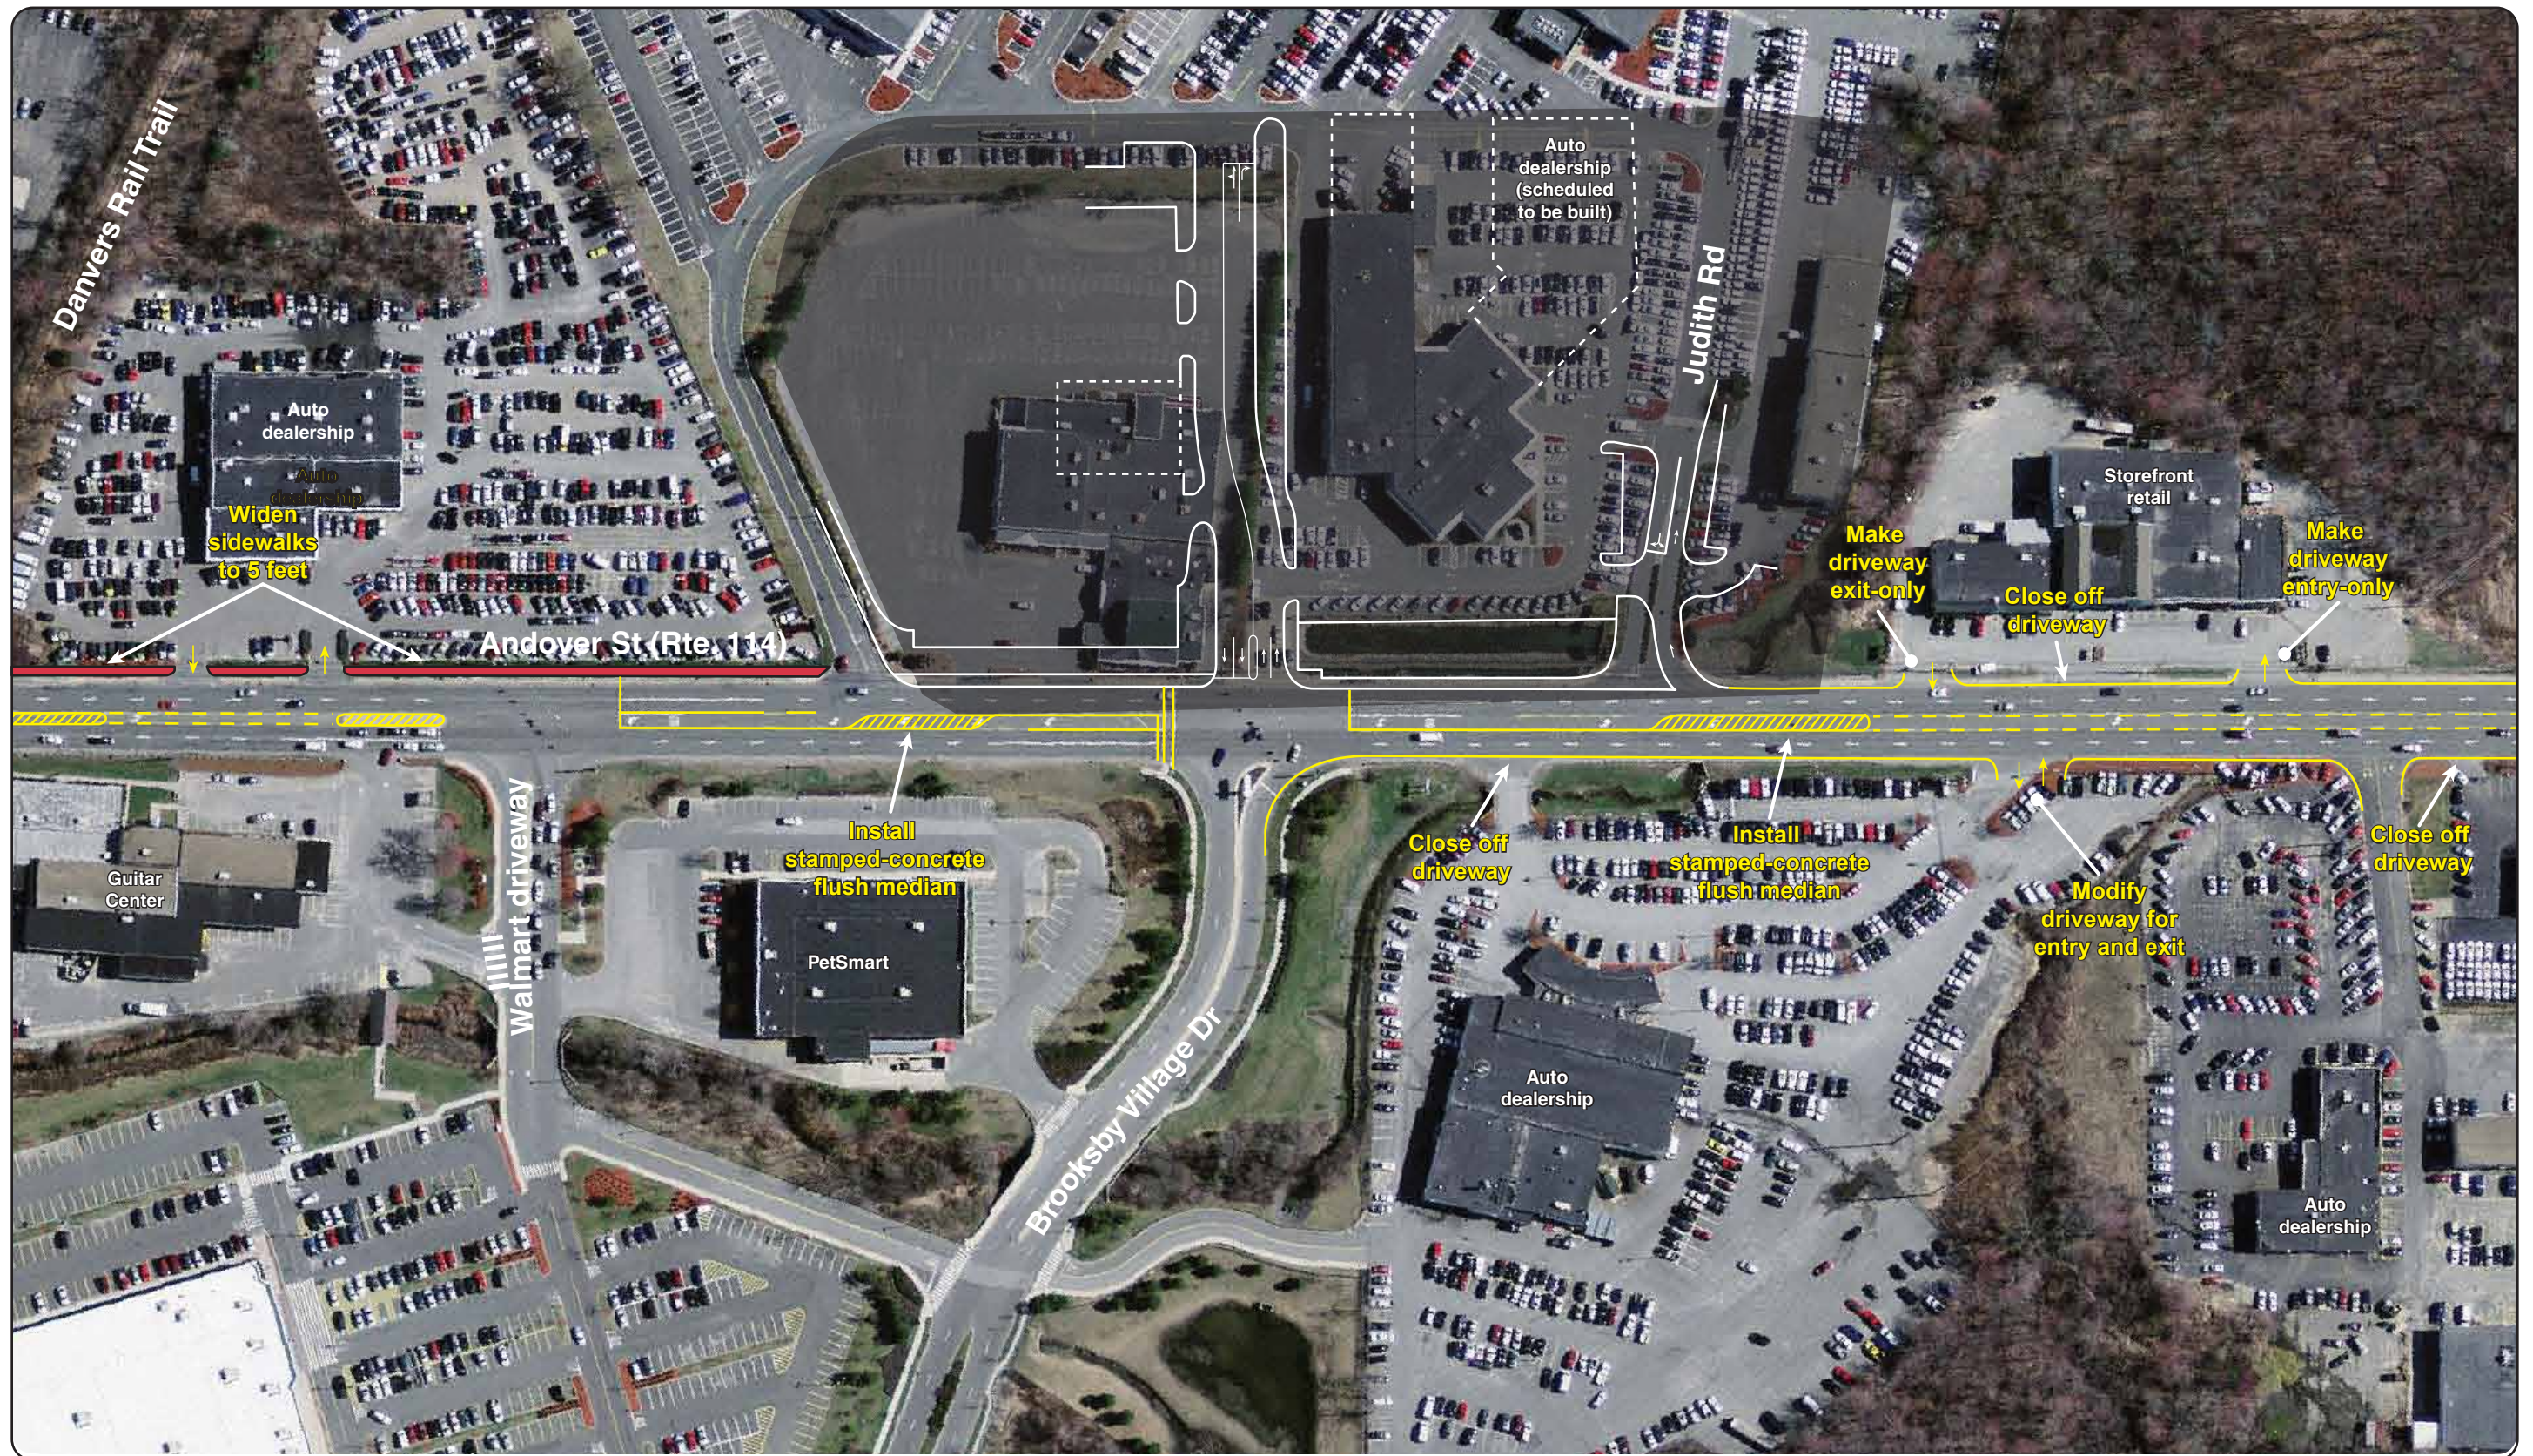
FIGURE 9
Proposed Long-Term Improvements – Alternative 1
Conceptual Plan (Middle Section)

- Install a stamped concrete flush median with left-turn bays in the section of Route 114 between Avalon Bay Drive and the Lowe's Driveway.
- Install a stamped-concrete flush median, with a left-turn bay in the westbound direction, in the section of Route 114 between the Lowe's driveway and Garden Street.
- Install a stamped concrete flush median in the section under the rail trail bridge.
- Install stamped-concrete flush medians at various locations between the Walmart driveway and Palmer Avenue (see Figures 9 and 10).

In addition to the proposed driveway treatments in the short-term improvement alternative, Alternative 1 proposes a number of driveway modifications in the section between the Walmart driveway and Palmer Avenue (see Figures 9 and 10).

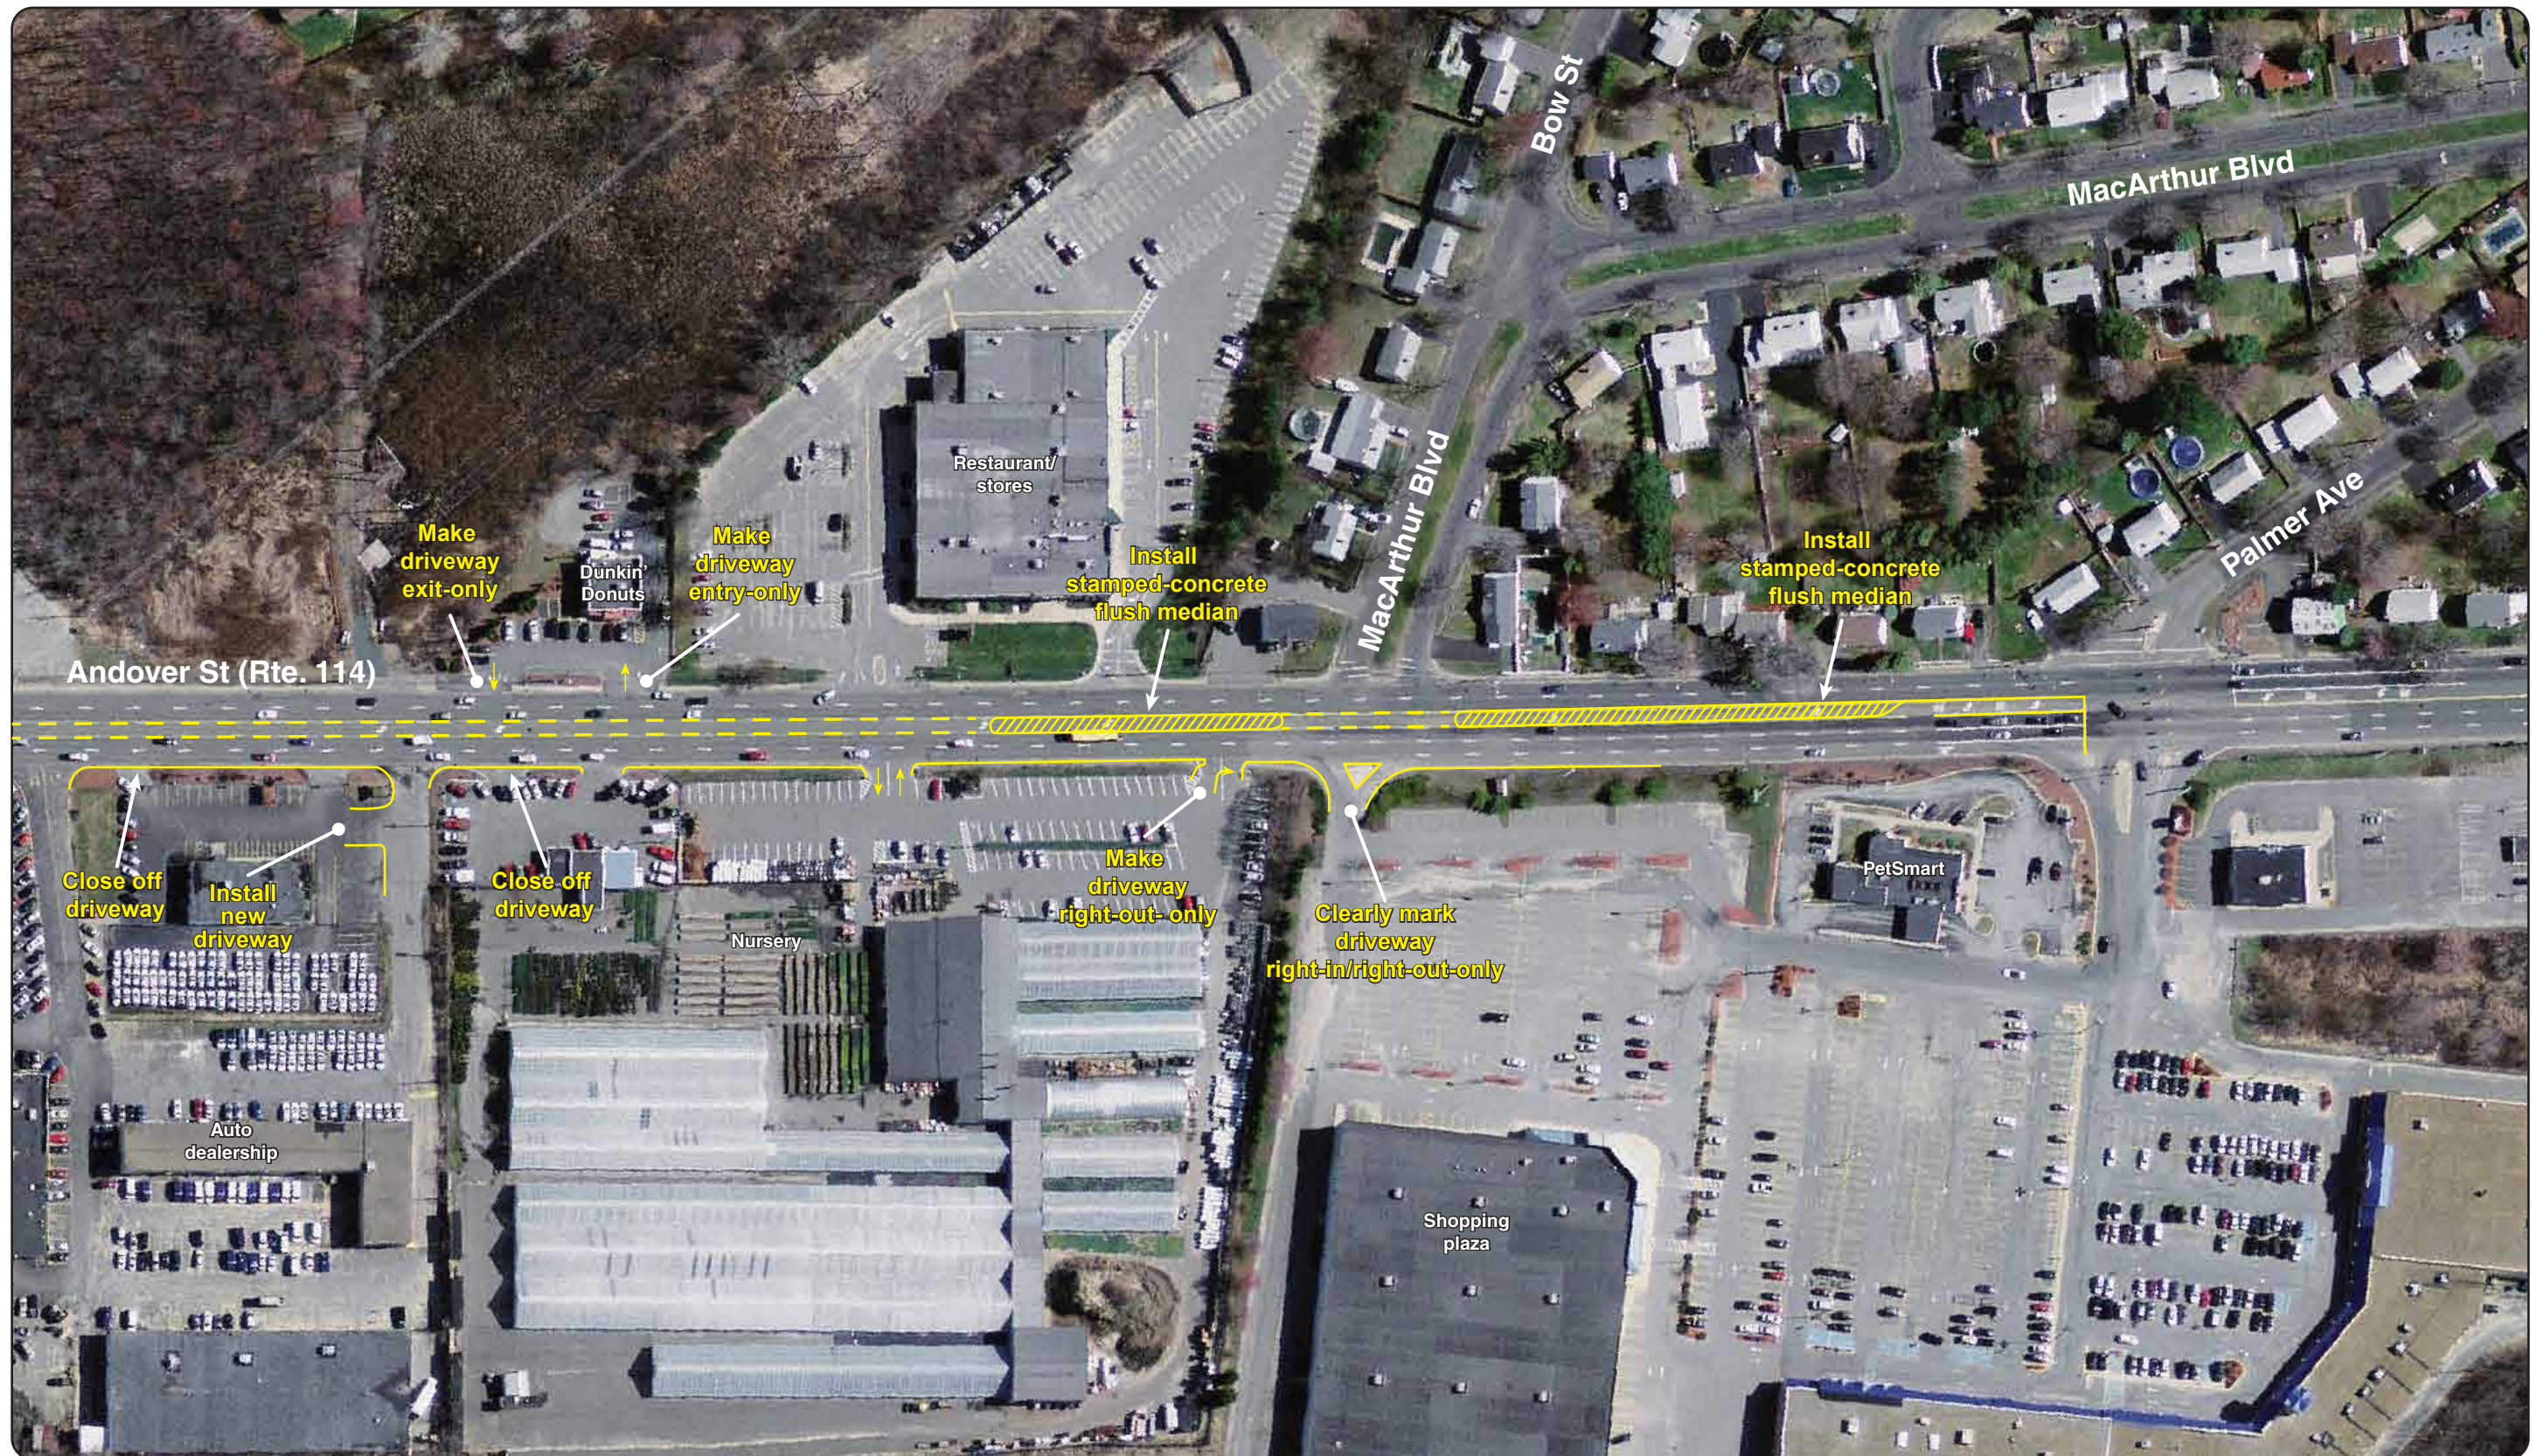
FIGURE 10
Proposed Long-Term Improvements – Alternative 1
Conceptual Plan (Eastern Section)

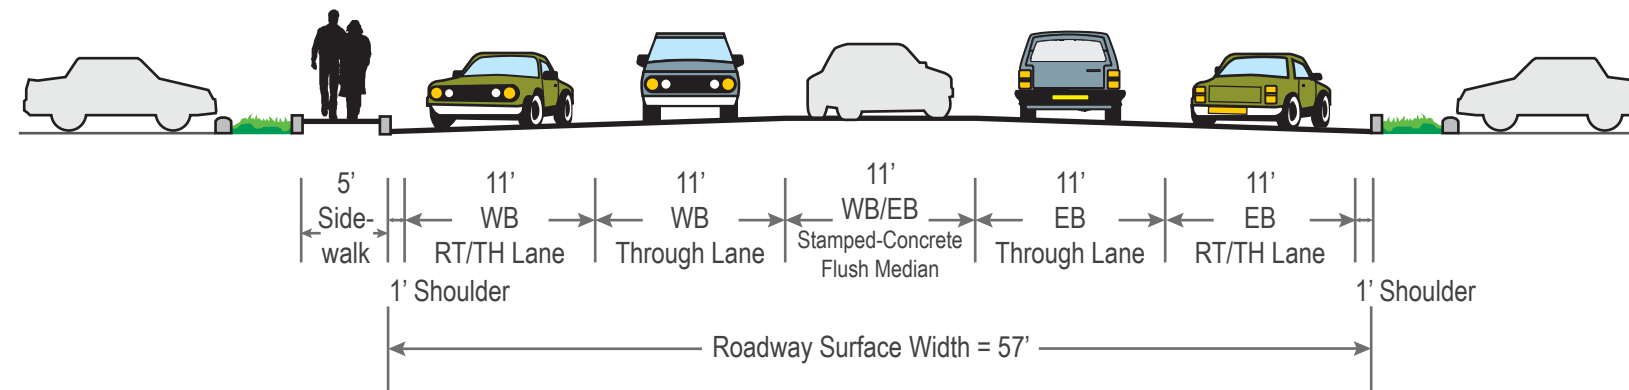
Cross-Section on Either Side of Rail Trail Bridge

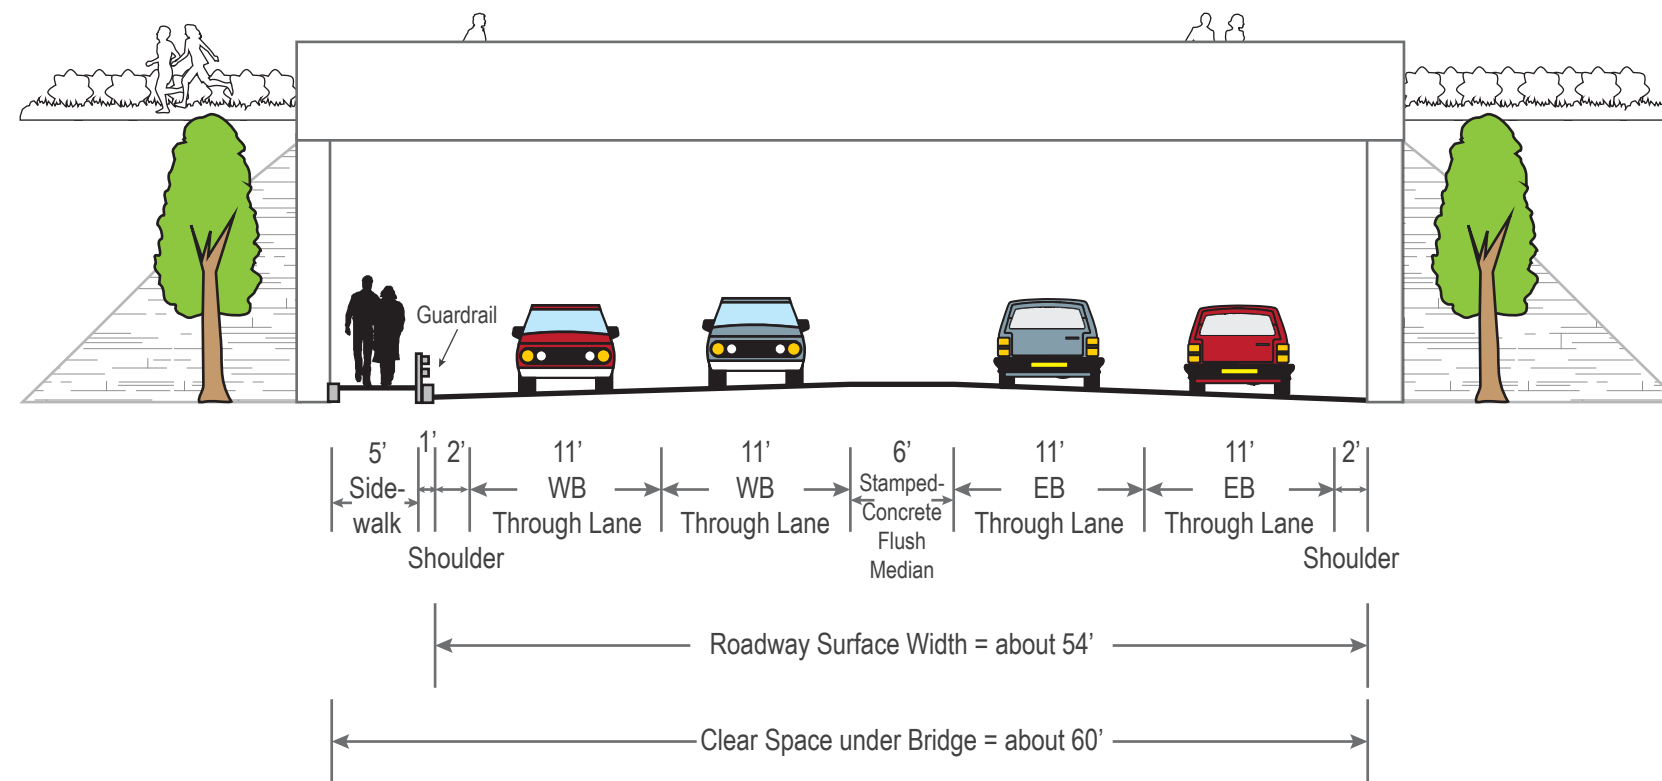
Cross-Section under Rail Trail Bridge

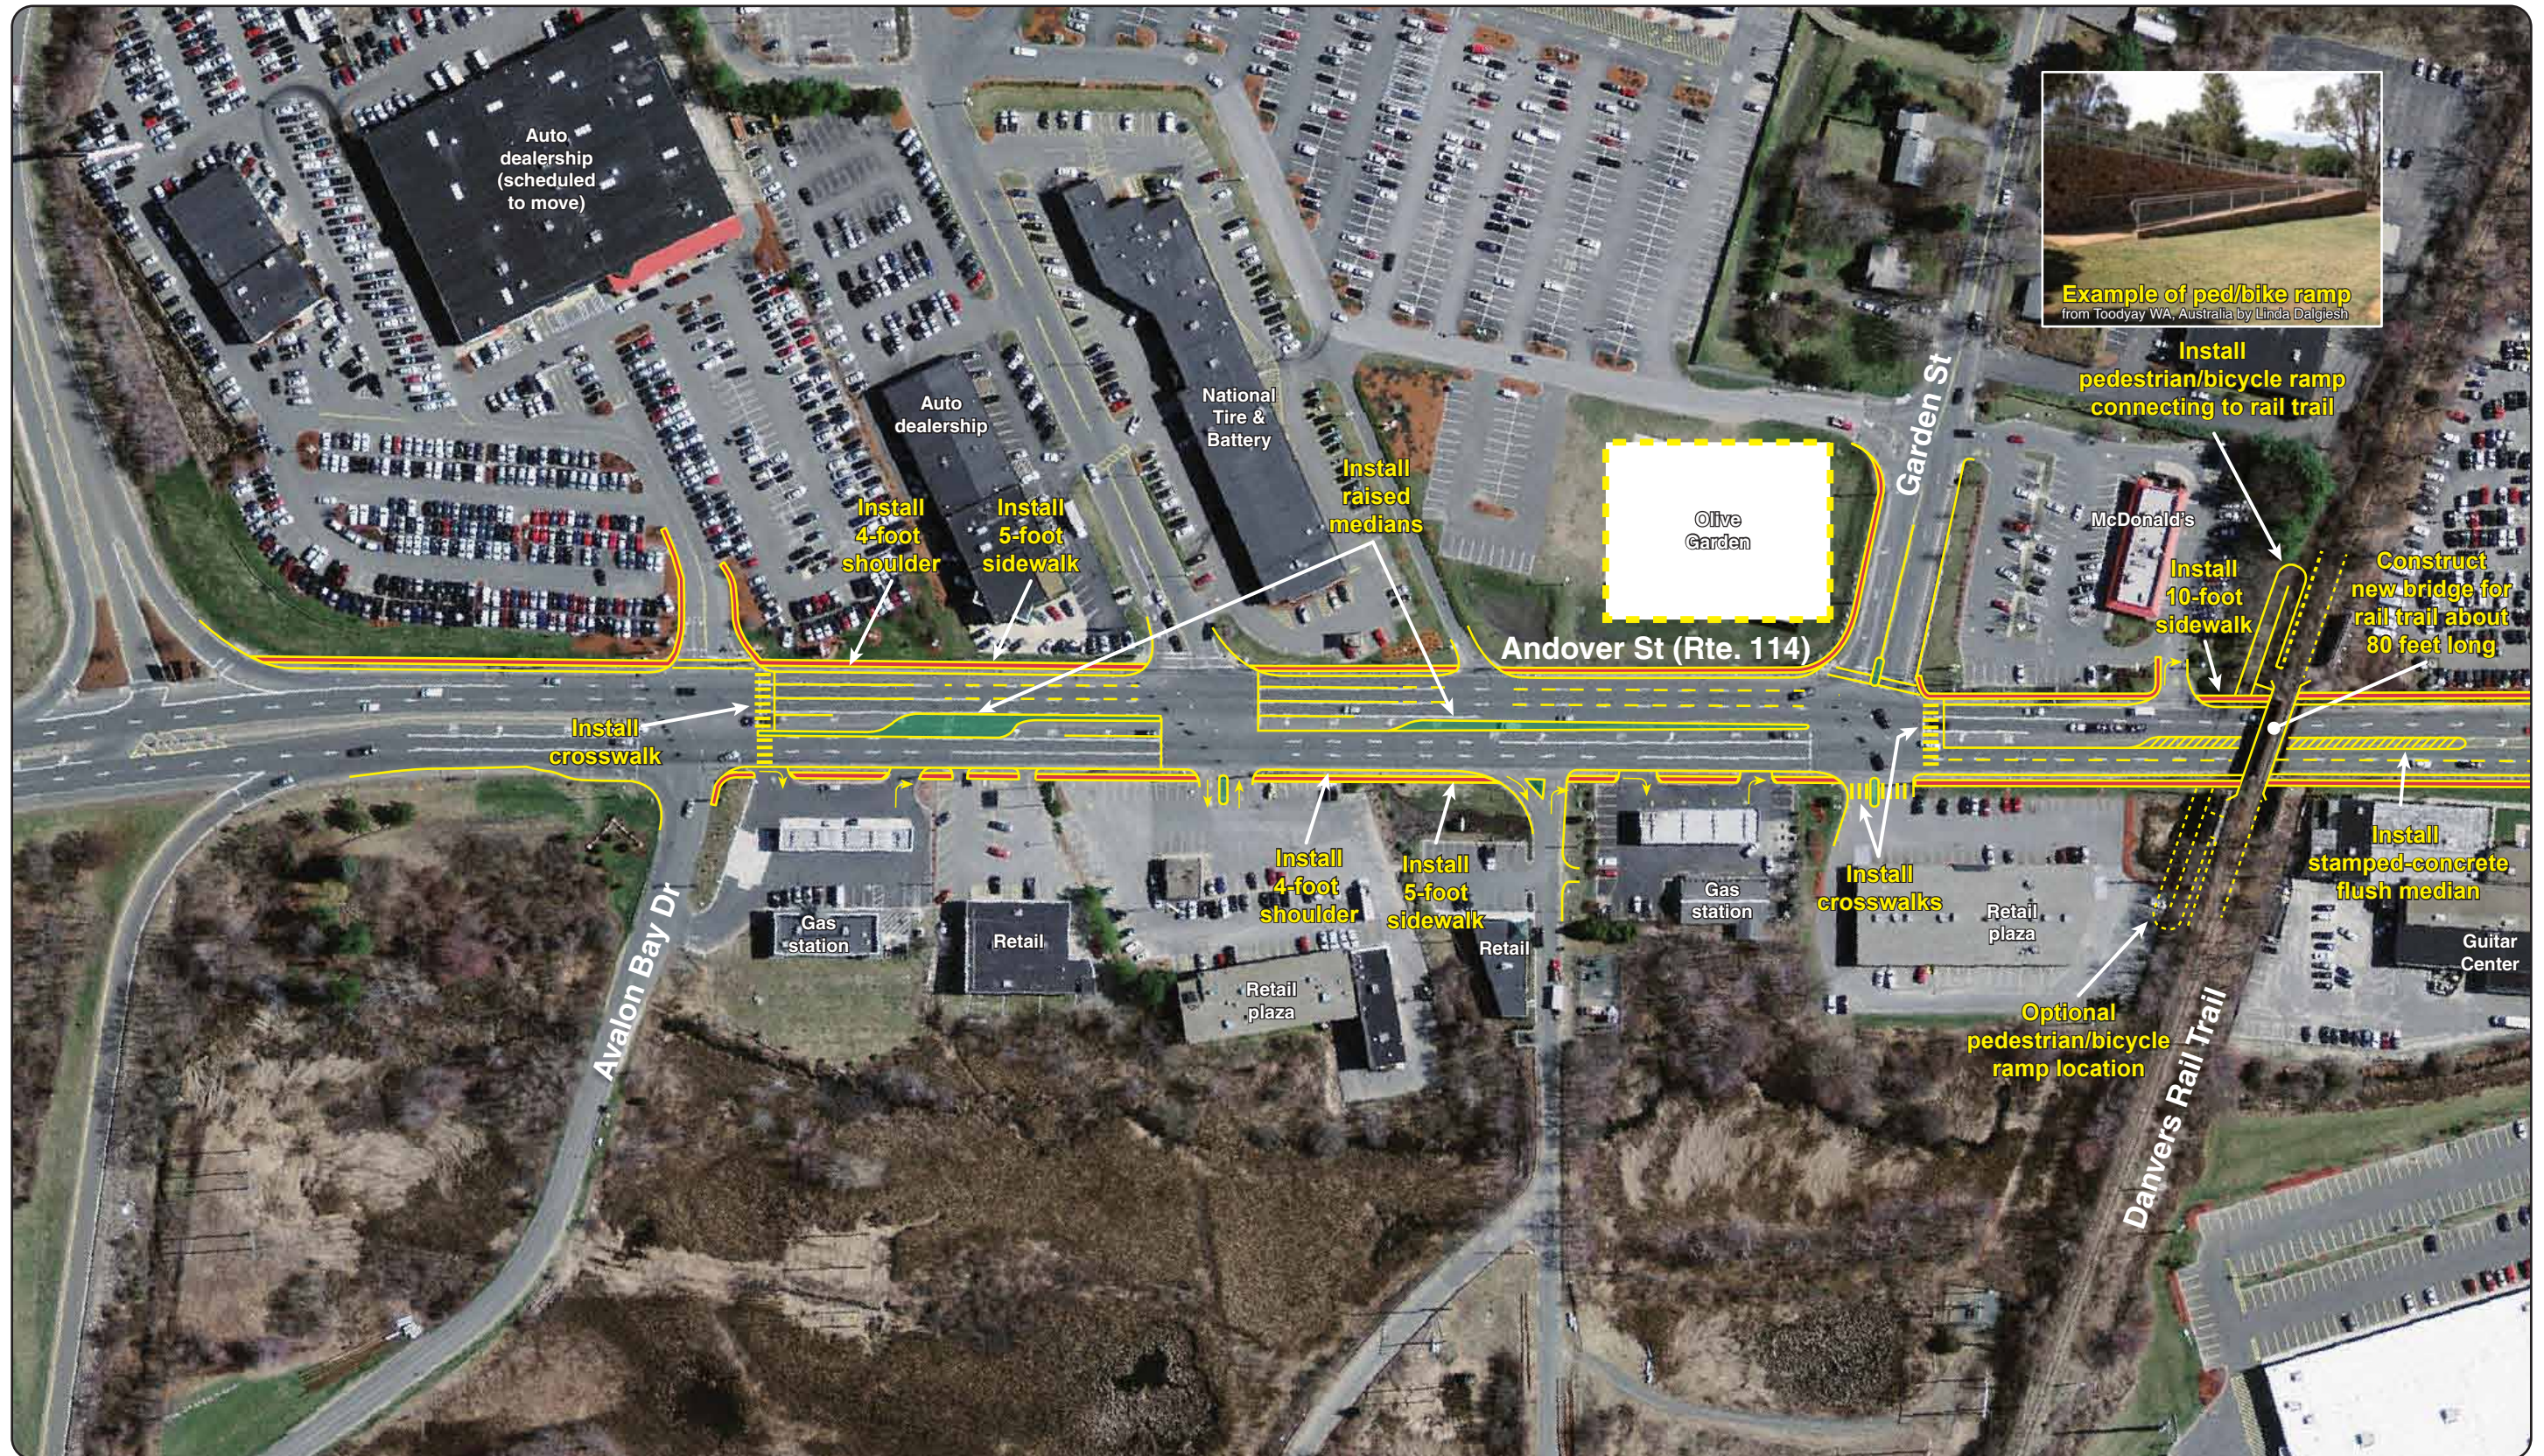
FIGURE 12
Proposed Long-Term Improvements – Alternative 2
Conceptual Plan (Western Section)

Figures 12, 13, and 14 show the locations and layouts of the proposed improvements of Alternative 2, in three parts (western, middle, and eastern) of the study corridor's conceptual plan. Figure 15 shows the proposed roadway cross-sections for Alternative 2.
