MEMORANDUM

DATE November 1, 2012
TO MassDOT Highway Division District 4
Town of Danvers
FROM Chen-Yuan Wang, Mark Abbott, Steven Andrews, and Christine Bettin
MPO Staff
RE Route 114 in Danvers, Interstate 95 to the Peabody City Line:
Safety, Operations, and Access Management Study

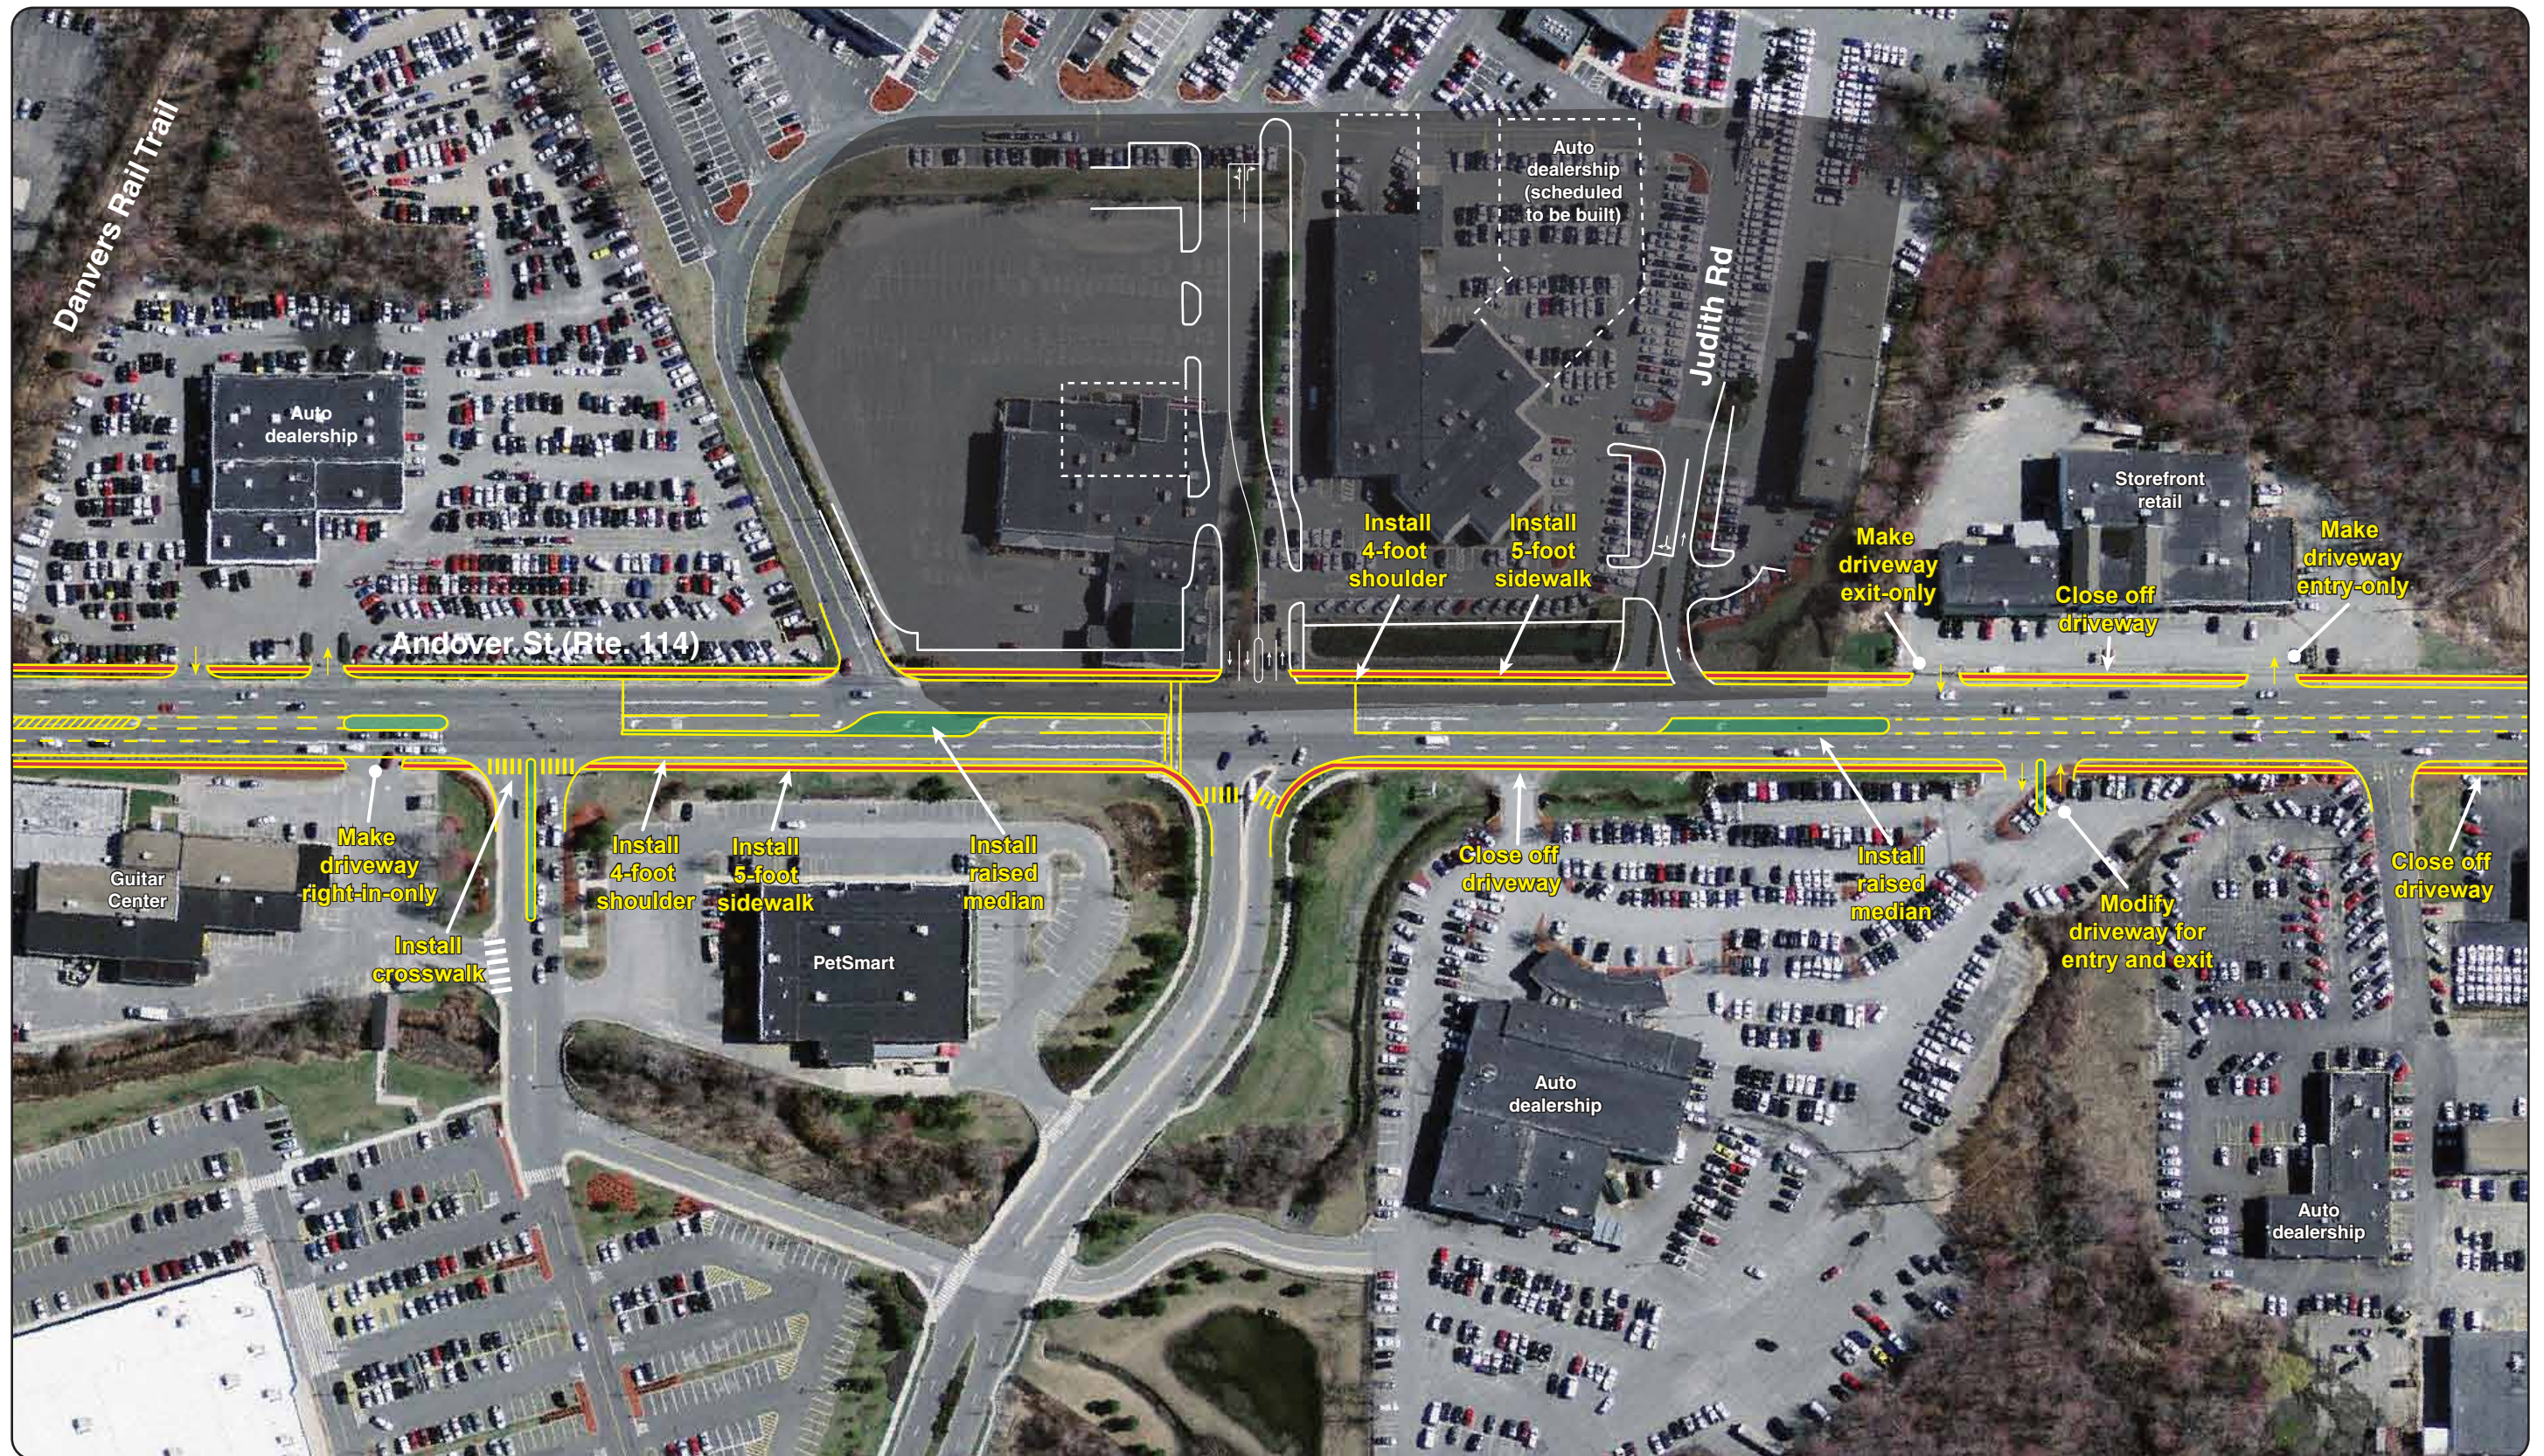
FIGURE 13
Proposed Long-Term Improvements – Alternative 2
Conceptual Plan (Middle Section)

Figures 12, 13, and 14 show the locations and layouts of the proposed improvements of Alternative 2, in three parts (western, middle, and eastern) of the study corridor's conceptual plan. Figure 15 shows the proposed roadway cross-sections for Alternative 2.

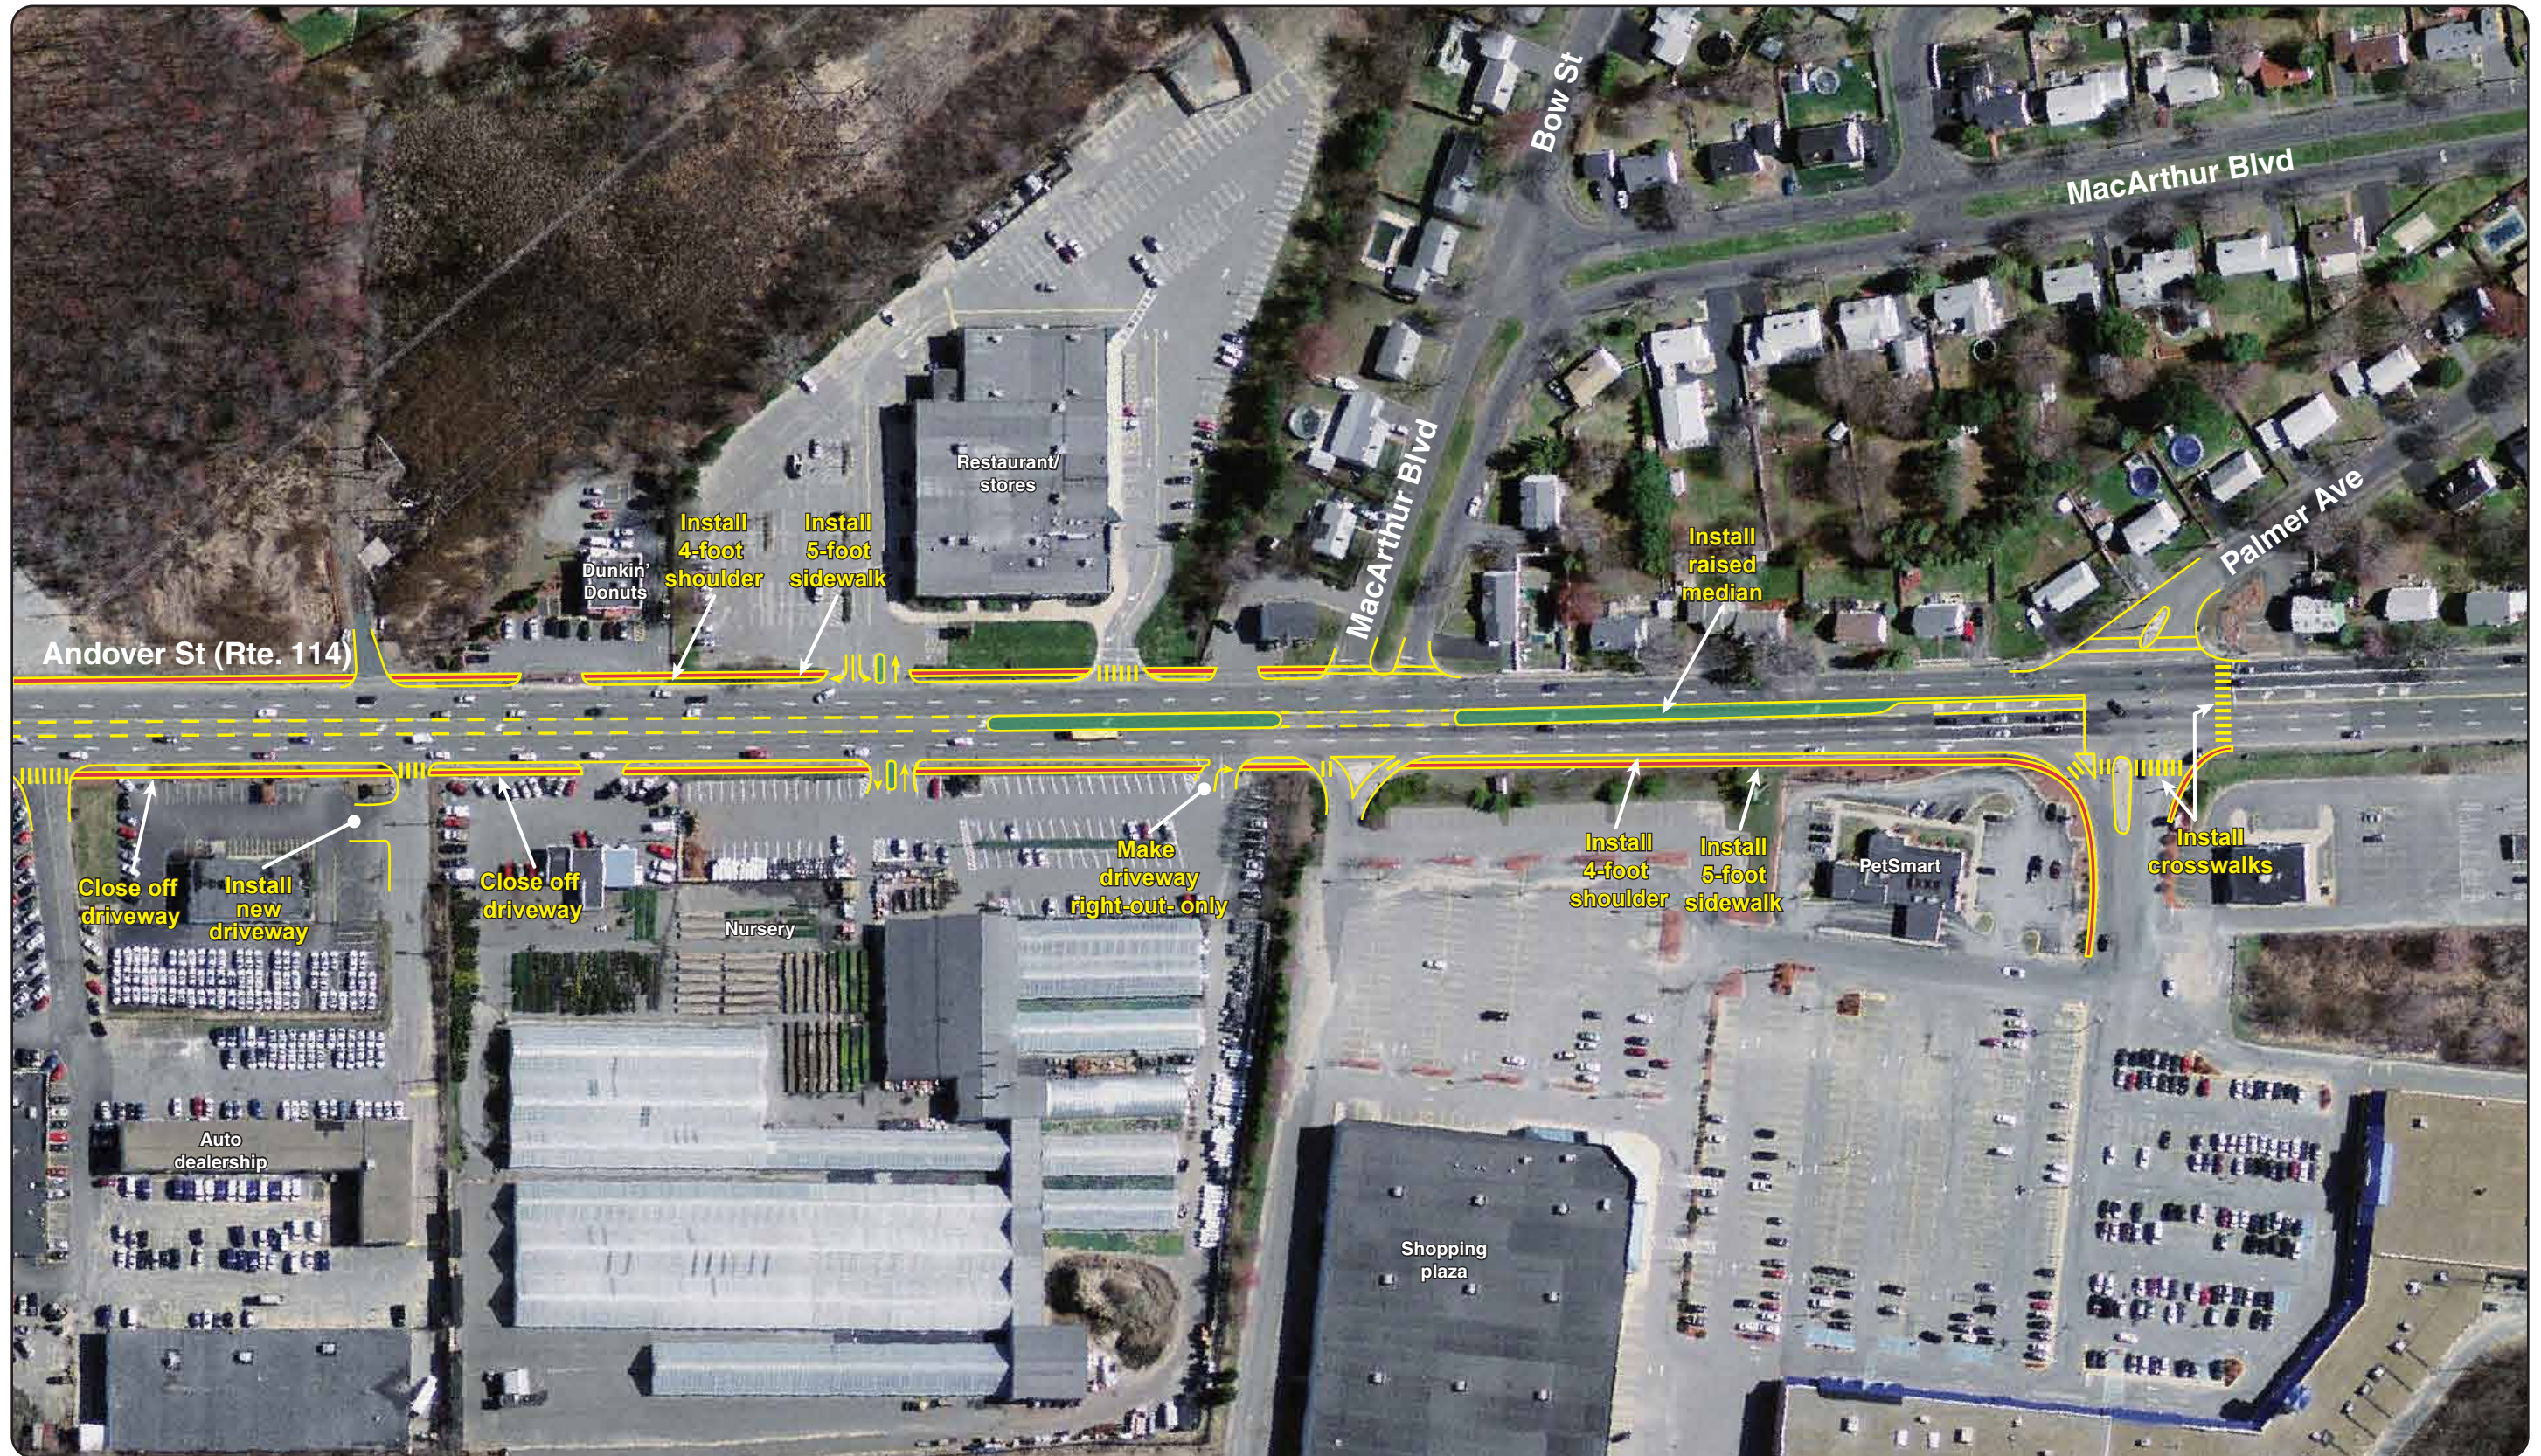
FIGURE 14
Proposed Long-Term Improvements – Alternative 2
Conceptual Plan (Eastern Section)

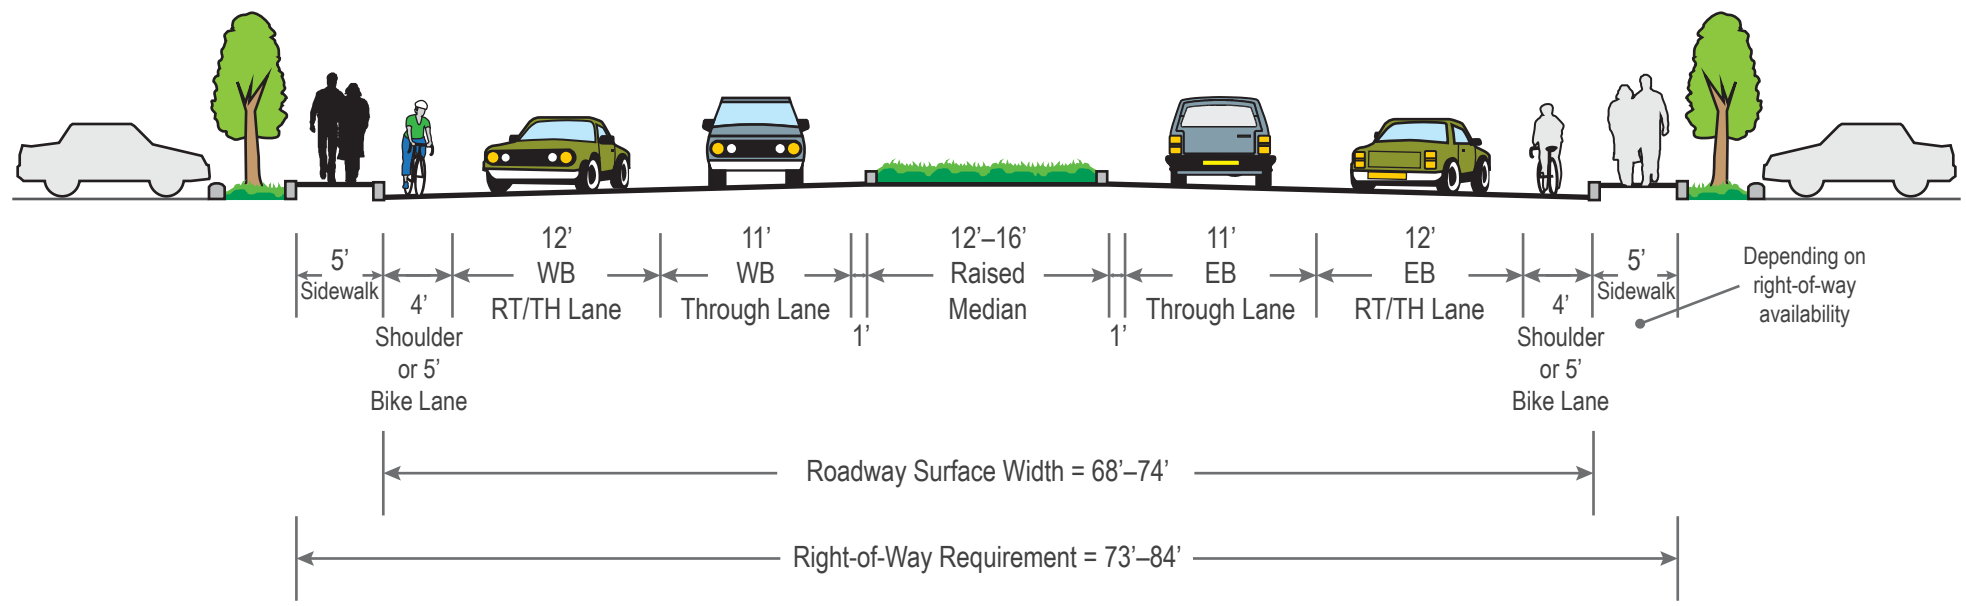
Typical Cross-Section with Raised Medians and 4' Shoulders/5' Bike Lanes

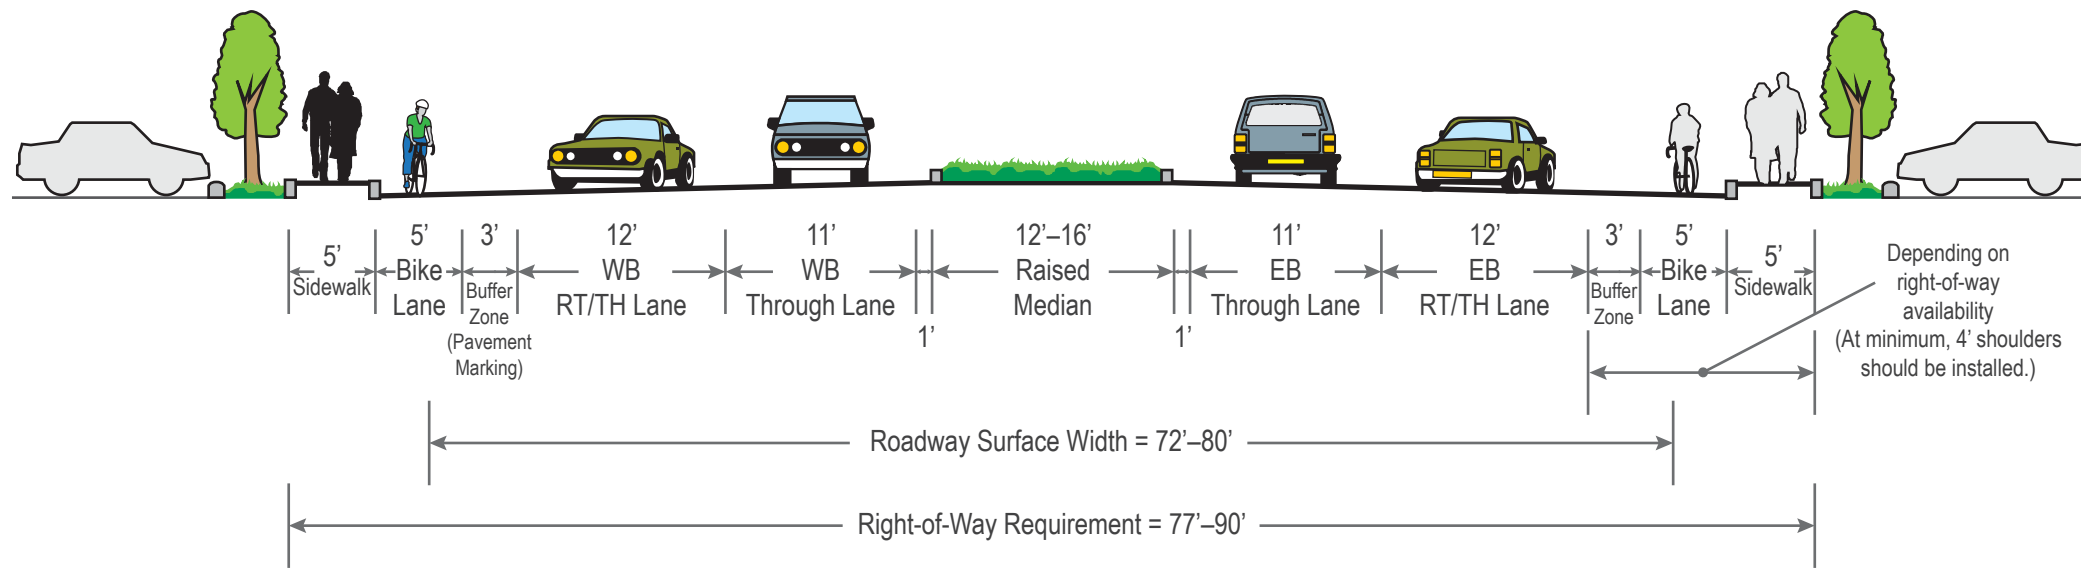
Typical Cross-Section of Buffered Bike Lanes Option
